NPIC/R-1583/63

PHOTOGRAPHIC INTERPRETATION REPORT

**MUNITIONS STORAGE SITE
NEAR KUN-MING, CHINA**

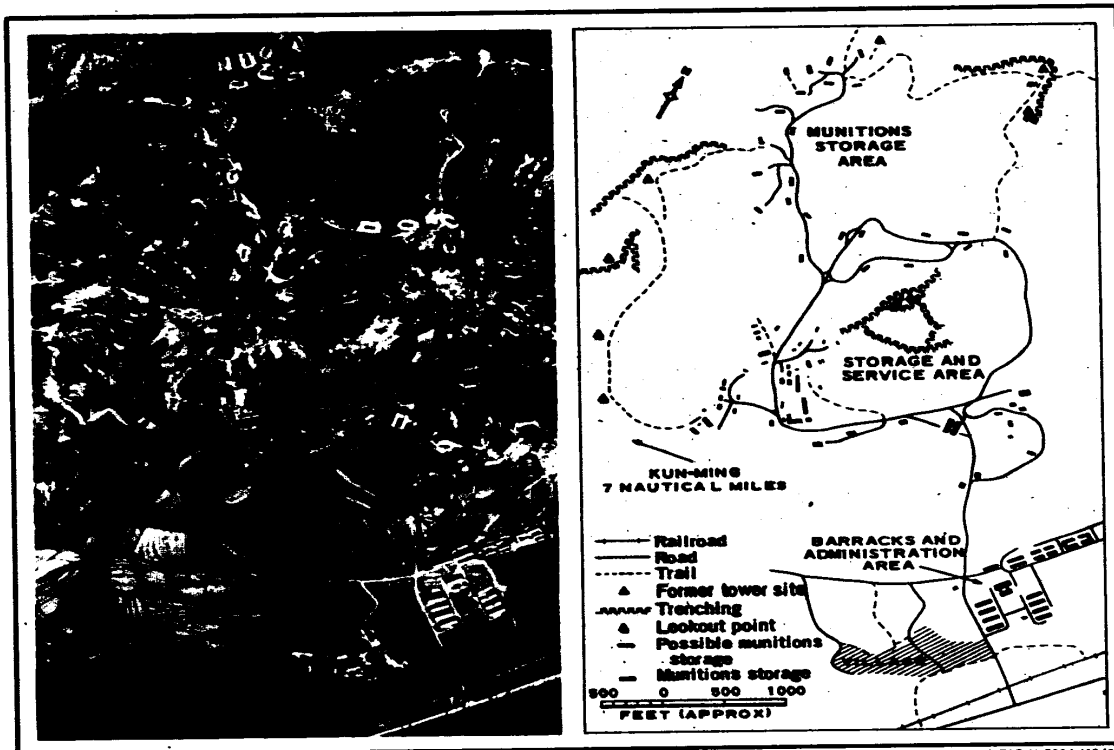
FIGURE 2. MUNITIONS STORAGE SITE NEAR KUN-MING, CHINA, [REDACTED]

and administration area (Figure 2). The latter areas are located in a valley SE of the munitions storage area. The site is close to a main rail line, but is road served only. Construction of the rail line began prior to [REDACTED] and was completed before [REDACTED]. A series of military installations, including probable explosives storage areas, are located along the railroad. Munitions Storage Area. The munitions storage area contains 25 dispersed storage buildings and one small building of unidentified

function. The storage buildings are gable roofed; no roof ventilators are visible. Three sizes of warehouses are discernible: 70 by 25 ft, 65 by 30 ft, and 50 by 25 ft. The total roof cover of the 25 warehouses is about 42,000 sq ft. This area was complete when it was first observed on photography of [REDACTED]

Security. Extensive trenching is visible along the perimeter of the munitions storage area and at lookout points, suggesting the use of troops for external security purposes. Three guard towers, observed on [REDACTED] photography, had been removed by [REDACTED]

Storage and Service Area. The storage and service area contains about 50 storage and support buildings, including at least 12 dispersed storage buildings possibly used for munitions. All the buildings in this area were present in [REDACTED]

Barracks and Administration Area. A barracks and administration area, located near the entrance to the site, contains 19 buildings including at least 15 barracks. Construction in this area was just beginning in [REDACTED] four barracks were incomplete as of [REDACTED]
